Revival of the '2926'

RESTORATION OF A STEAM LOCOMOTIVE IS A LABOR OF LOVE

STEAM ENGINE RENOVATION

Renovate the “2926” — a 1944 steam engine abandoned in 1956 in Albuquerque’s Coronado Park

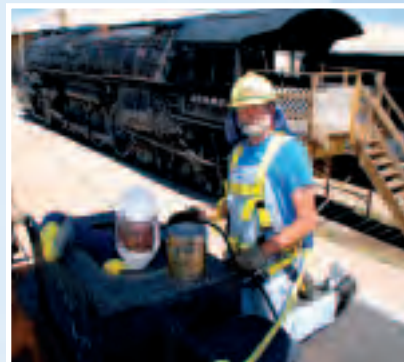
The Santa Fe "2926," a 1944 steam locomotive left abandoned in an Albuquerque city park a half-decade ago (background), may pull excursion trains once again. It has been adopted by the New Mexico Steam Locomotive and Railroad Historical Society, whose members volunteer several hours a week to its restoration. The cleaning and coating of the "2926" began in April 2003 and is expected to take at least six more years.

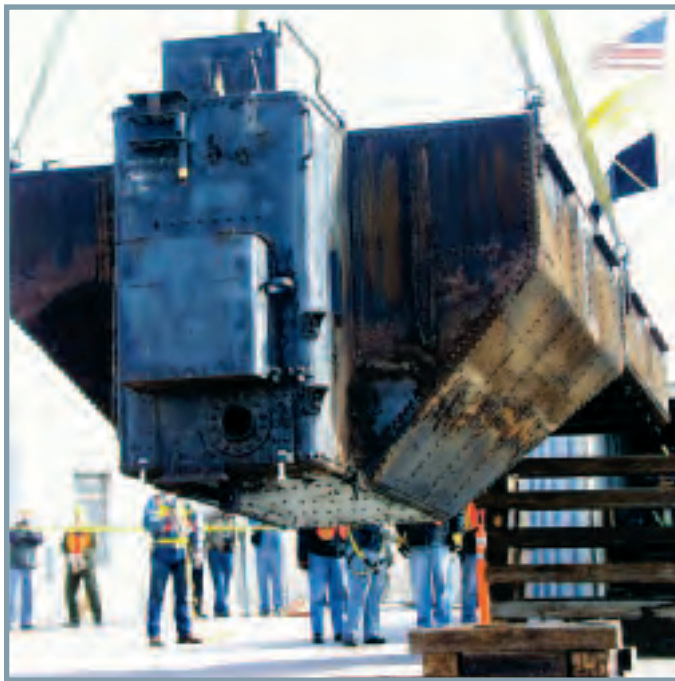
Caked with grease, asphalt, calcium carbonate, and rust and reeking of petroleum fumes, the fuel tank is a surface prep nightmare. Volunteers working inside the tank and its inner sandbox are required to have confined-space training and must wear safety harnesses and respirators with supplied air. Interior work is restricted to half-hour increments and carefully monitored by Jon Spargo, the Society’s safety officer.

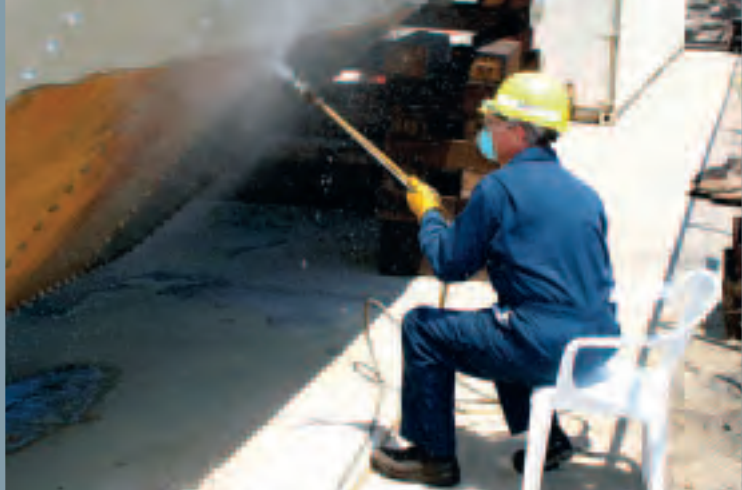
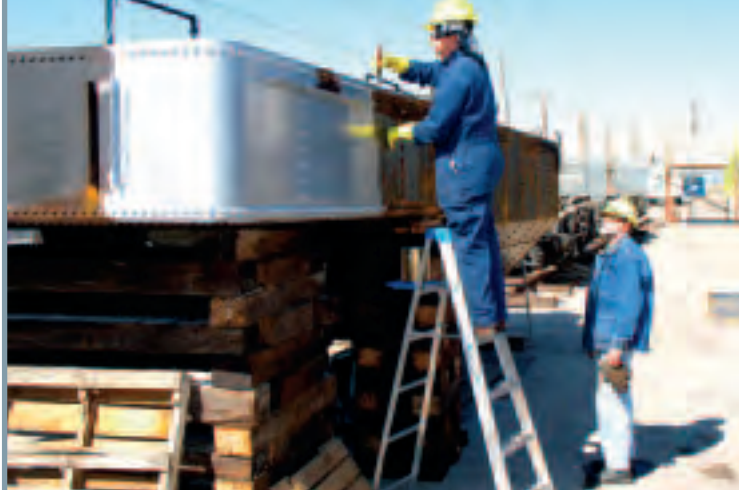
Operating a Troy-Bilt pressure-washing unit equipped with a media-blast delivery system (*left*) is one of the many hands-on jobs tackled by the enthusiastic volunteers, whose weekday professions range from radiologist to pastor. United by a love of steam locomotives, they are devoting hours of manual labor to restore the locomotive to its original condition. A silver coat of Rust Bullet (*right*) forms an impenetrable layer that protects the heavily riveted-steel fuel tank from corrosion. Originally invented to protect jets’ wingtips from abrasion during flight, the single-component, moisture-cured urethane is brushed, rolled, or sprayed over light rust or clean metal. A second coat will bring the thickness to about 12 mils DFT.

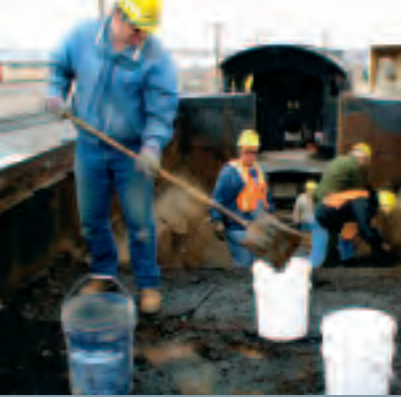
Several hundred pounds of calcium carbonate are shoveled from the cavity where the fuel tank originally rested on the locomotive's tender car. The tender, attached to the rear of the "2926," held the water and oil that fed the engine. With volunteers who are "long on enthusiasm, but short on experience" working just a few hours a week, the task seems
